CAUSES, MEASUREMENT, AND ELIMINATION
OF FUEL-ELEMENT FISSION PRODUCT
LEAKAGE AT THE NASA PLUM BROOK REACTOR

by A. Bert Davis and Richard H. Brickley
Lewis Research Center
Cleveland, Ohio

NATIONAL AERONAUTICS AND SPACE ADMINISTRATION • WASHINGTON, D. C. • AUGUST 1969

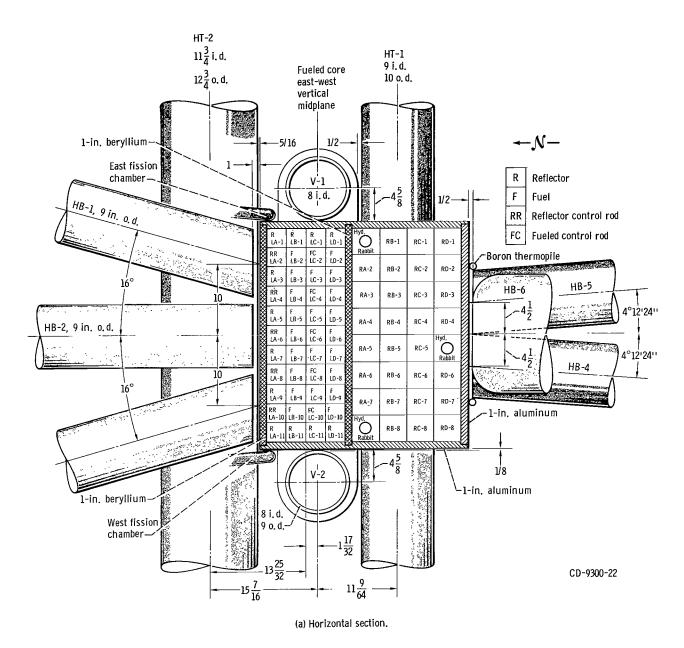
Figure 2. - Reactor core. (Dimensions are in inches.)

When beryllium is exposed to fast neutrons, embrittlement and gas formation result. This gas formation caused the south beryllium plate (fig. 2) of the PBR core box to bow toward the core. After about 37 000 megawatt days (3.2×10¹² kW-sec) of reactor operation, the embrittled plate cracked. Since the beryllium plate was installed with nonaccessible bolts and because it had swelled, the plate was removed by a remote electrical discharge machining (EDM) method. More information on the beryllium distortion and replacement can be found in reference 1. A chip collection system and an underwater vacuum cleaning system were used to keep the PCW System clean during the EDM operations.

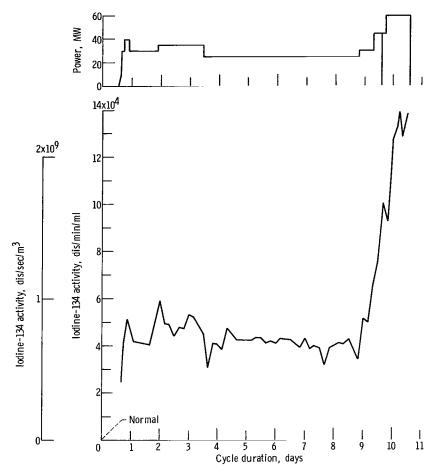
Figure 3. - Primary water activity. Cycle 80; core 3.

The I¹³⁴ level for a typical cycle with no leaking fuel elements varies in the range of 1000 to 3500 disintegrations per minute per milliliter $(1.67\times10^7 \text{ to } 5.85\times10^7 \text{ dis/sec/m}^3)$. The I¹³⁴ level for cycle 80 is shown in figure 3. Cycle 80 had higher fission product levels (140 000 dis/min/ml (2.34×10⁹ dis/sec/m³)) than any other cycle in the history of PBR operation. As is obvious from the magnitude of the I¹³⁴ levels in figure 3, the levels were kept within allowable, safe limits by reactor power decreases and cycle terminations.

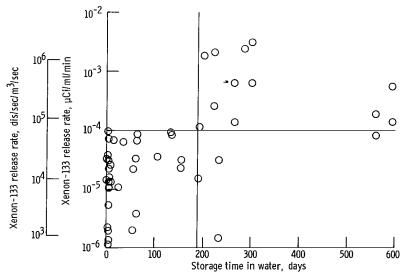
No correlations were found with average and peak-to-average burnup or element fabrication date. A correlation between element leakage and storage time in water was found. Figure 4 shows that the ${\rm Xe}^{133}$ release rate in the dry sipping operation is less than 10×10^{-5} microcuries per milliliter per minute $(6.2\times10^4~{\rm dis/sec/m}^3)$ for a water storage time of less than 190 days. This storage time does not include the time the elements were operated in the high-quality PCW System. Although the 10×10^{-5} microcuries per milliliter per minute $(6.2\times10^4~{\rm dis/sec/m}^3)$ cannot be stated as a definite dividing point between a leaking element and a contaminated element, it is close to the proper value. The water during this storage period varied between 1 and 30 micromhos per centimeter. It ranged between 5 and 30 micromhos per centimeter for 70 days and between 3 and 5 micromhos per centimeter for 10 days of this storage period. Otherwise it was below 3 micromhos per centimeter.

Figure 4. - Fuel-element test results.
